An Archaeological Curation-Needs Assessment for Headquarters Air Combat Command

Volume 1

United States Air Force
Air Combat Command

7. PERFORMING ORGANIZATION NAME(S) AND ADDRESS(ES) U.S. Army Corps of Engineers, St. Louis District 1222 Spruce Street (CELMS-PD-C) St. Louis, Missouri 63103-2833			8. PERFORMING ORGANIZATION REPORT NUMBER Archaeological Curation-Needs Assessment Technical Report No. 10, Volume 1

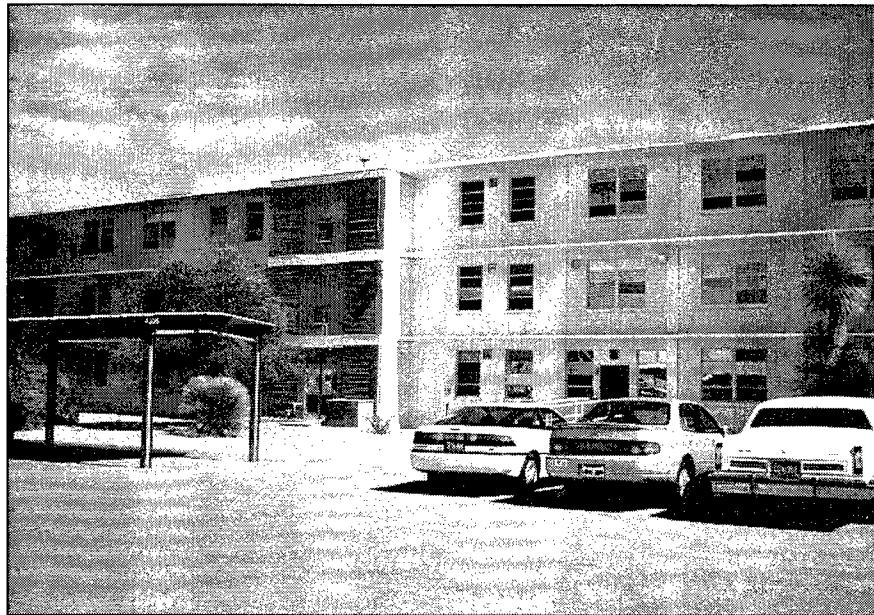
Figure 1. Exterior of Building 4300, where archaeological collections are stored.

in two offices on the second floor of Building 4300 on Davis-Monthan AFB. Building 4300, which functions primarily as space for offices, is located at 5285 East Madeira Street at the base (Figure 1). Two of the offices on the second floor house the administrative records for archaeological projects as well as an interpretive display, which includes the only artifact retained from the base collection.

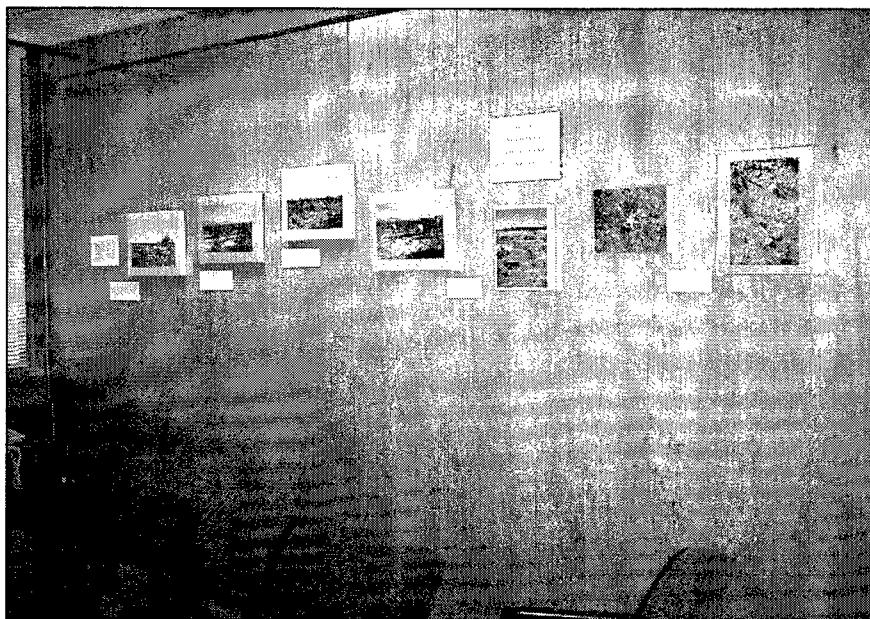
Only one artifact is currently located on base. It is a pottery sherd that has been mounted to foam-board backing and incorporated into the interpretive display for the base. All other artifacts in the display are replicas (Figure 3).

Figure 3. The single artifact stored on base (not shown) is included in an interpretive display located on the wall of a conference room in Building 4300.

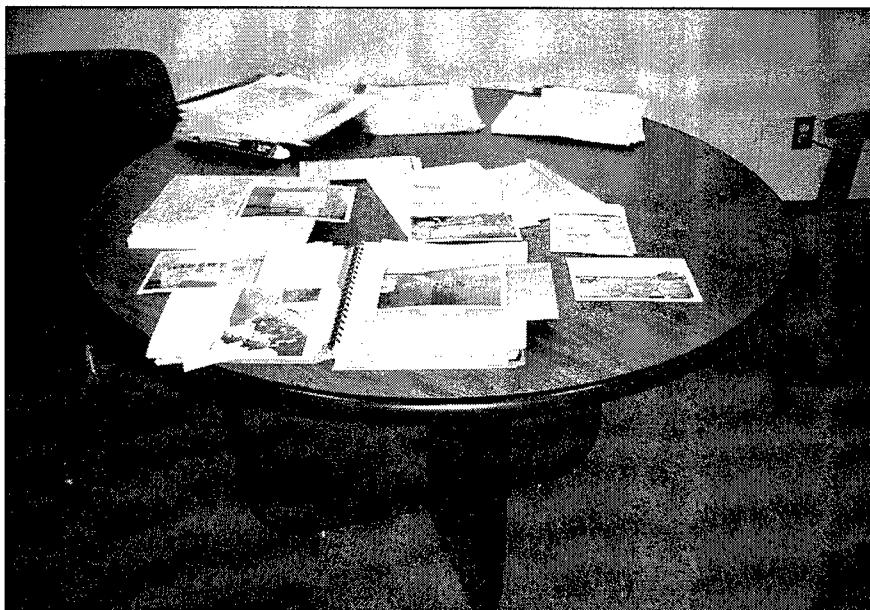
Four-by-six-inch black-and-white photographs and color slides are not labeled and are kept in manila folders with the written documentation (Figure 4). Eight-by-ten-inch color photographs, which are part of the interpretive display, have been placed on cardboard backing and enclosed within clear plastic box frames (see Figure 3).

Figure 4. Associated documentation for Davis-Monthan AFB collection showing interspersed photographic materials.

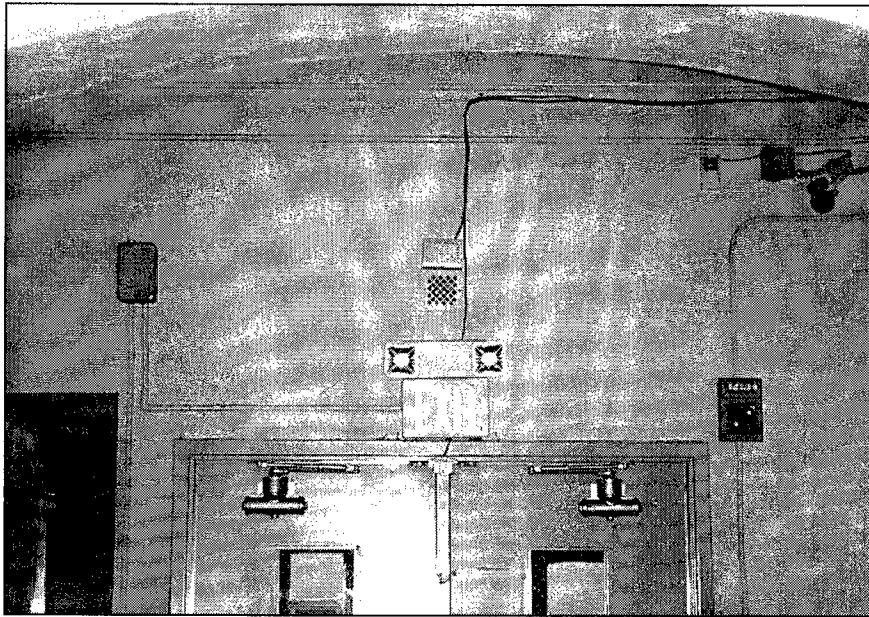
Figure 6. Security measures in ASM's North Building are more stringent than those installed in the South Building.

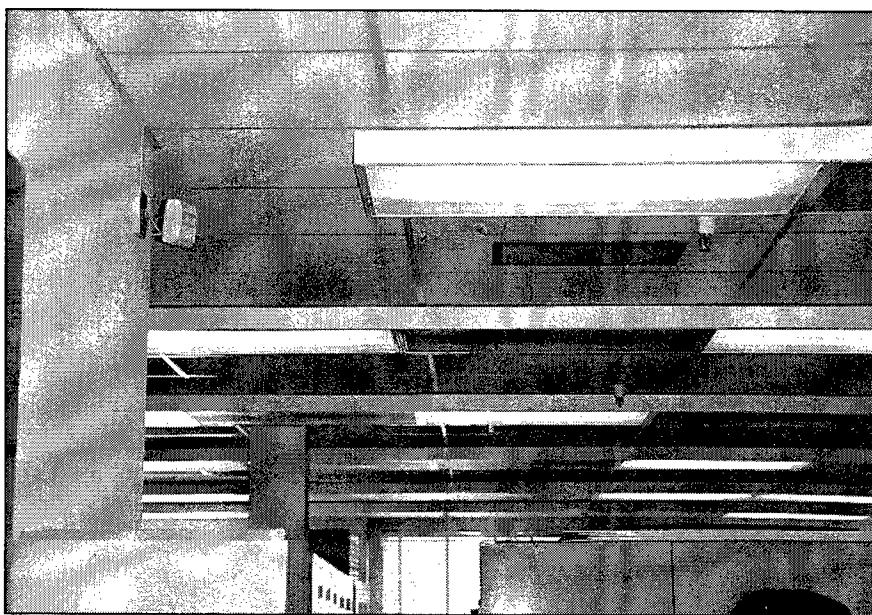
that are wired into the local fire department. In addition, the South Building has a sprinkler system, smoke detectors, heat sensors, and fire extinguishers (last inspected in July 1994) located throughout the repository. Sprinklers are not located above any boxes in the collections area. Fire doors are located at entryways to the collections area (Figure 7). Fire-proof cabinets

Figure 7. Overhead sprinkler system in the laboratory of ASM's South Building.

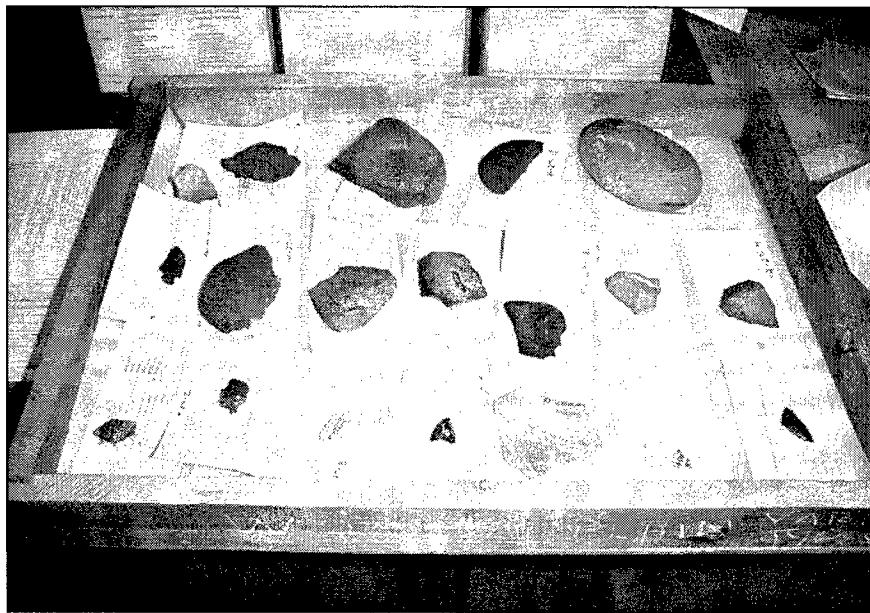
Figure 8. Cataloged collections from Davis-Monthan AFB are appropriately labeled and stored on ethafoam in wooden drawers.

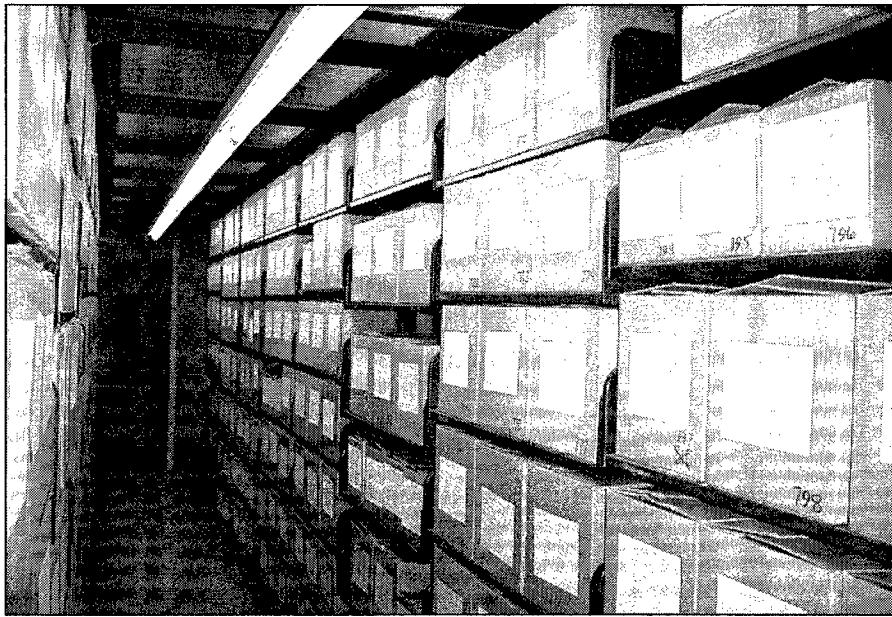
Figure 9. Research collections stored in the stacks of ASM's South Building.

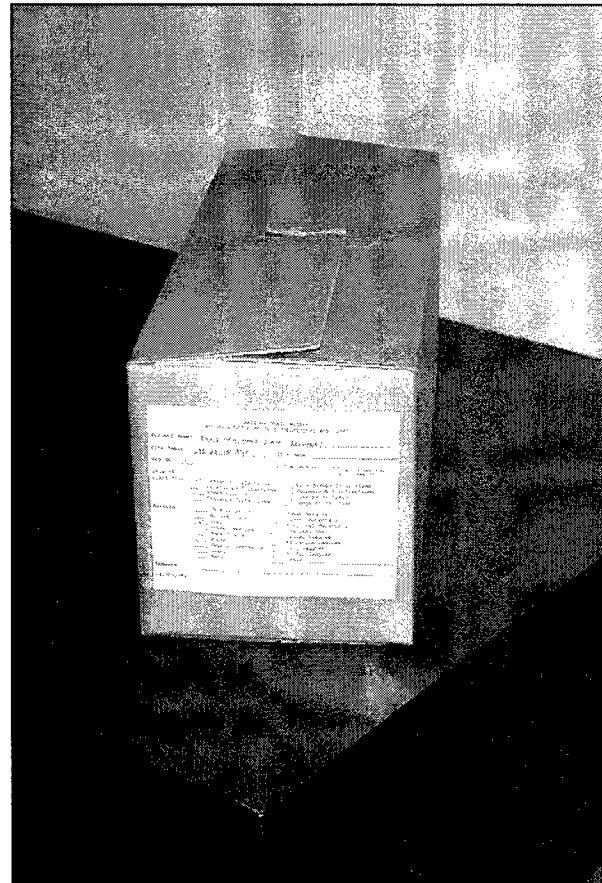
Figure 10. Example of a primary container, with a preprinted label, housing Davis-Monthan AFB materials.

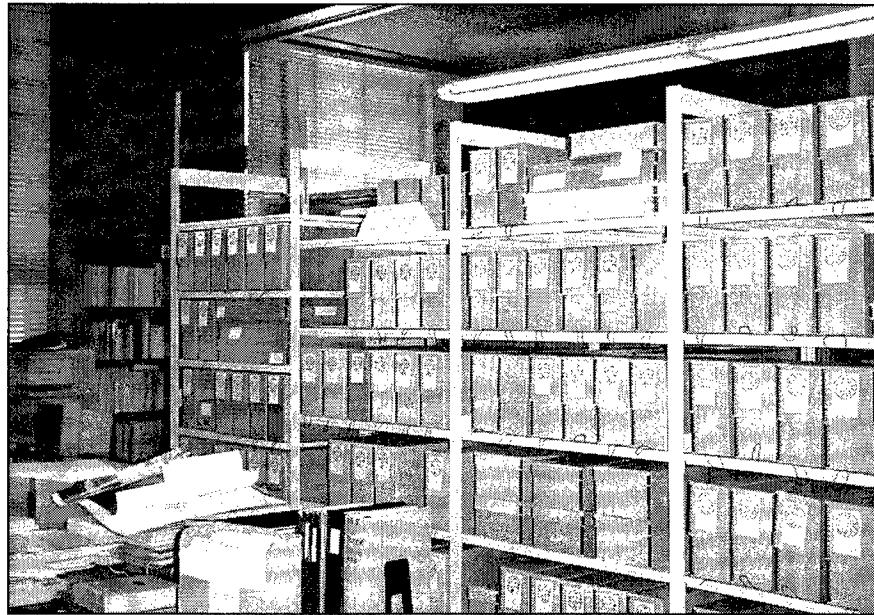
Figure 11. Processed collections are integrated into ASM's archival holdings.

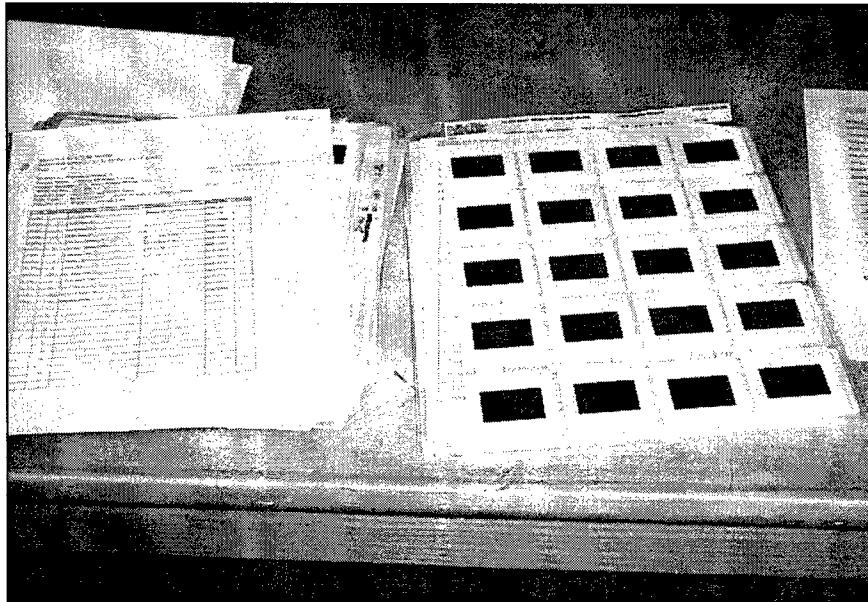
Figure 13. Davis-Monthan AFB photographic documentation awaiting processing (North Building).

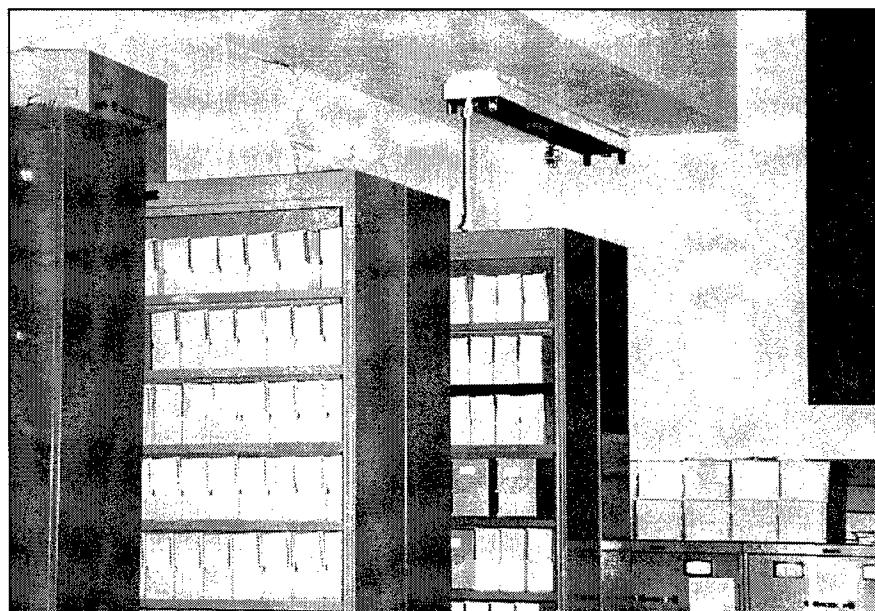
Figure 15. After processing, photographs are integrated into the ASM photographic archive (North Building).

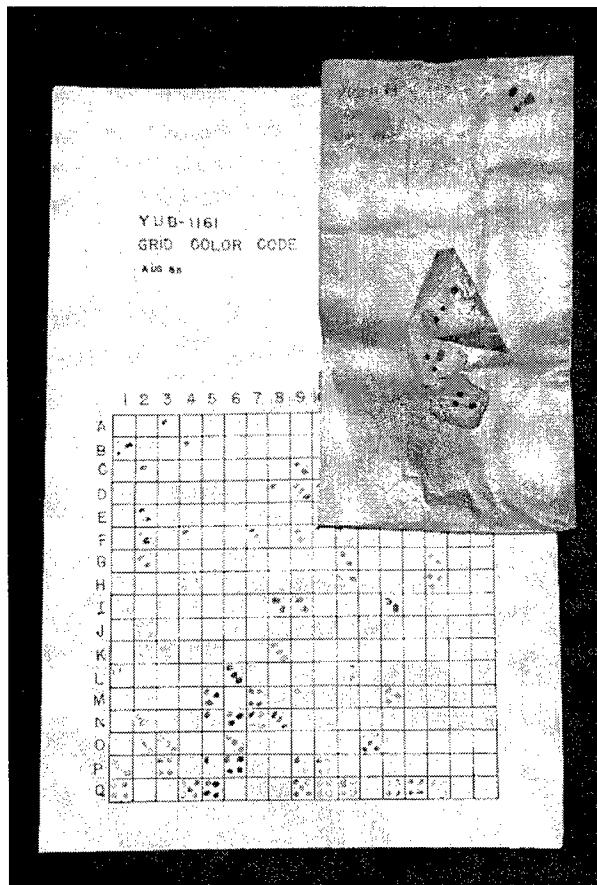
All of the artifacts are labeled, cleaned, and sorted. Labeling consists of color codes painted directly on the artifact. These codes correspond to the secondary container and designated grid square provenience (Figure 17).

Figure 17. Artifacts and associated secondary container with grid color code for labels.

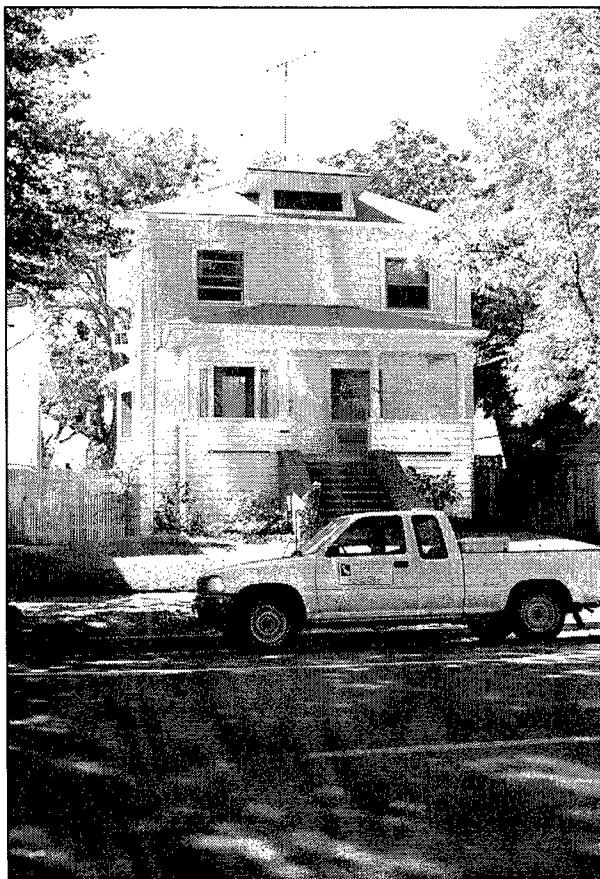
Figure 18. A two-story residence serves as offices for PAR Environmental Services.

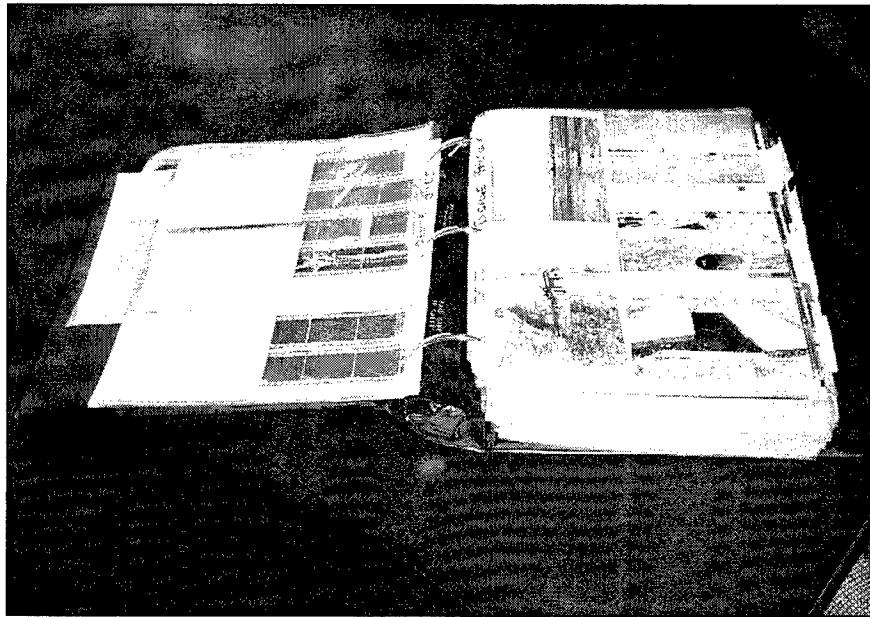
Figure 19. Photographic documentation from Beale AFB.

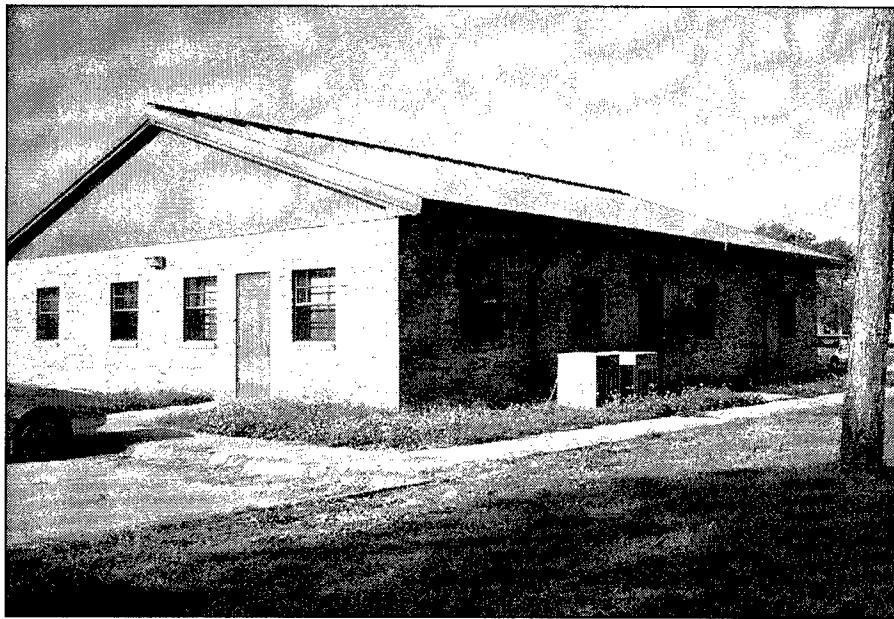
Figure 20. Exterior of Building 475. The entrance to the collections storage area is on the opposite side of the building. Note the heat pumps used for environmental control.

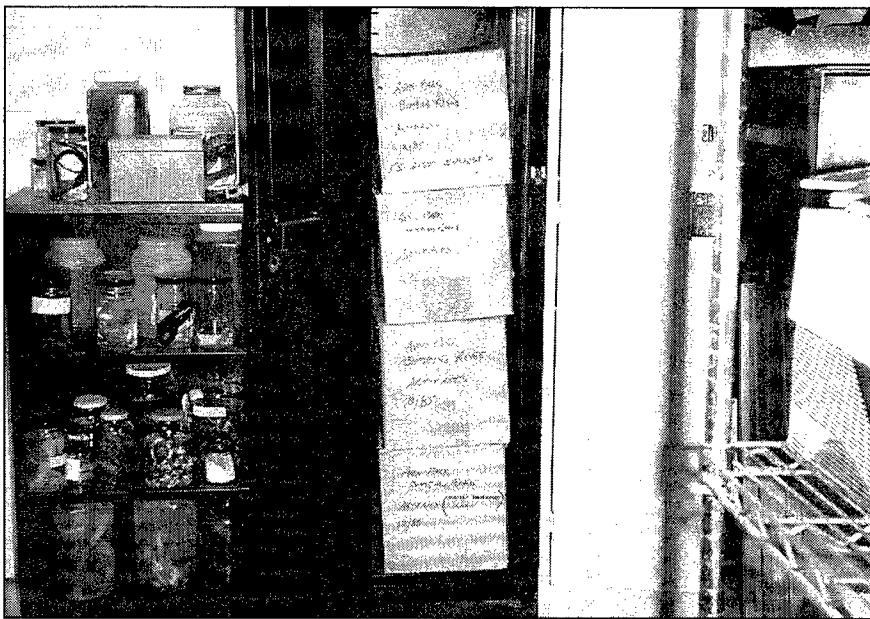
Primary containers consist of four boxes constructed of glued acidic cardboard with folded flap lids. Tape has been used to secure and reinforce the bottoms of the boxes, which measure 12.5 x 12 x 12 inches (l x w x h; approximately 1 ft³ each). Because of the way the boxes are stored, some have begun to show compression

Figure 21. The Avon Park AFR collection is stored in metal cabinets next to biological specimens. Note the damage to primary containers due to stacking.

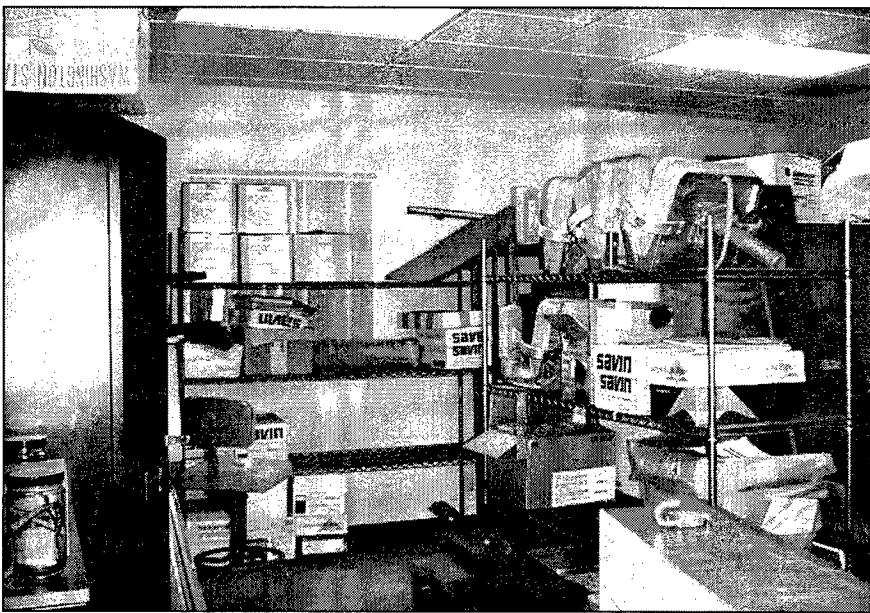
Figure 22. Collection storage area in the Environmental Flight Annex.

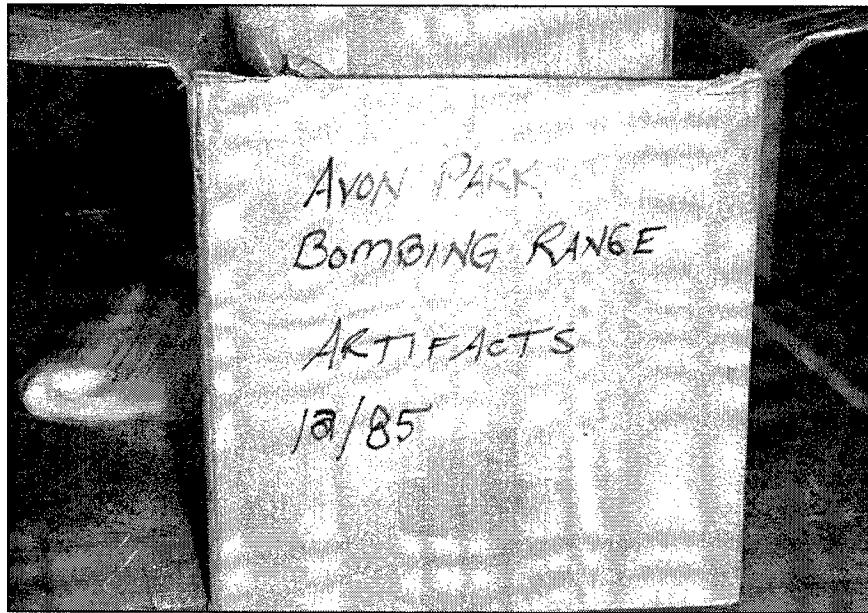
Figure 23. Damaged primary container. Note the direct labeling in marker.

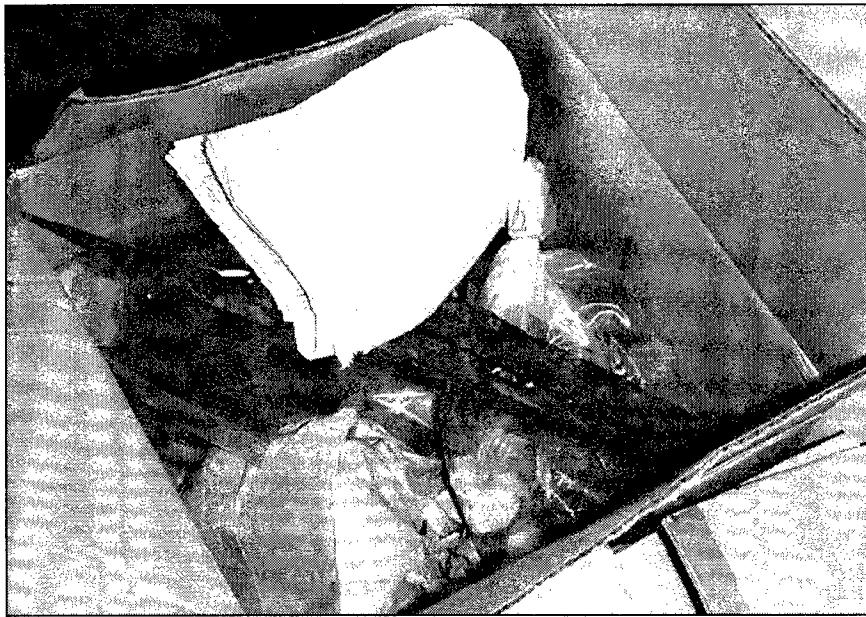
Associated documentation for this collection consists of an artifact inventory that was placed in the first box of artifacts (see Figure 24).

Figure 24. A variety of secondary containers packed together with the box inventory.

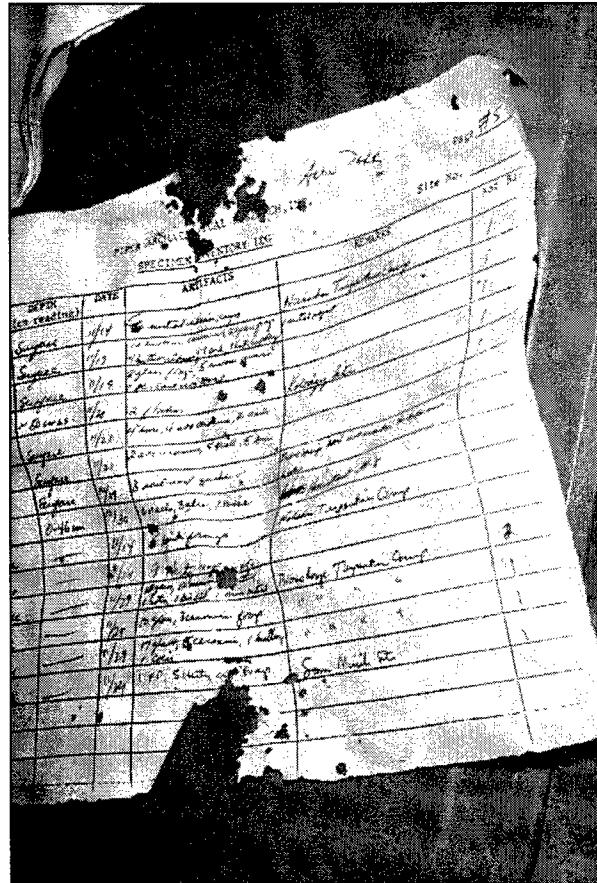
virtually illegible because of holes chewed into the paper (Figure 25). If this problem is not rectified immediately, the information will be lost.

1. Implement a professional pest-management system for the facility. Address the current spider and silverfish infestations.
2. Install smoke detectors and an overhead sprinkler system in the collections storage area.

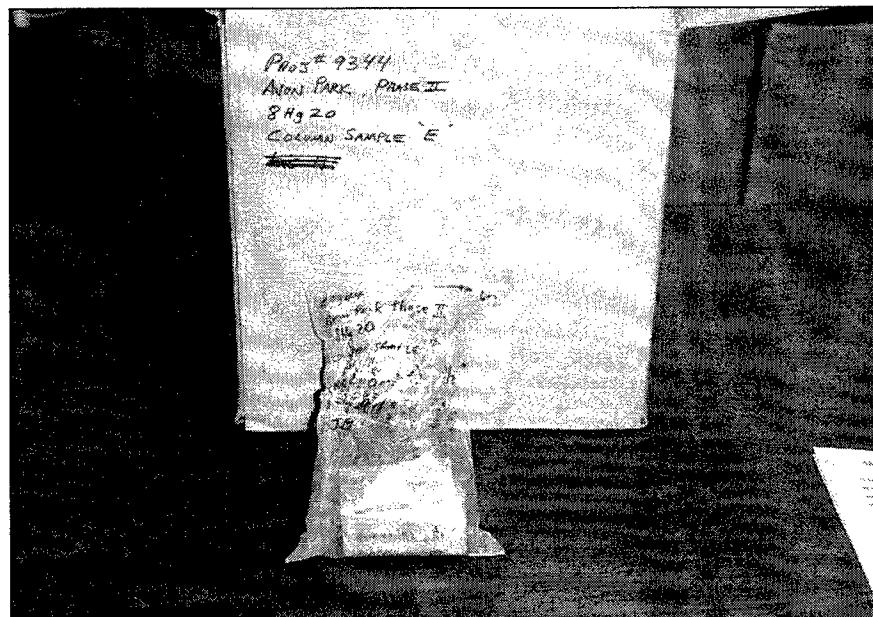
Figure 26. Two boxes are stored in the laboratory at JANUS Research. Primary and secondary containers are labeled directly in marker.

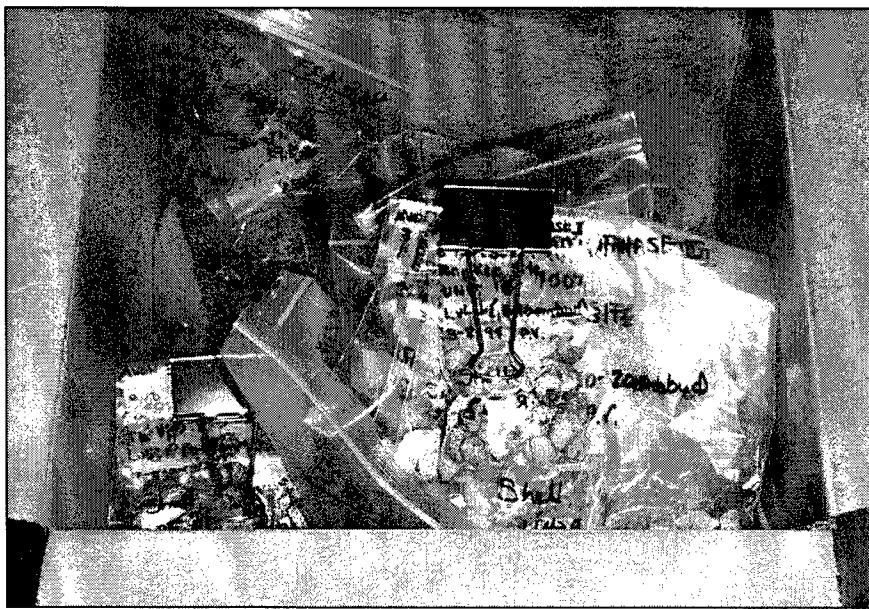
Figure 28. Two-mil, zip-lock bags are used to store materials from Avon Park AFR. Bags are labeled directly in marker; interior labels are absent.

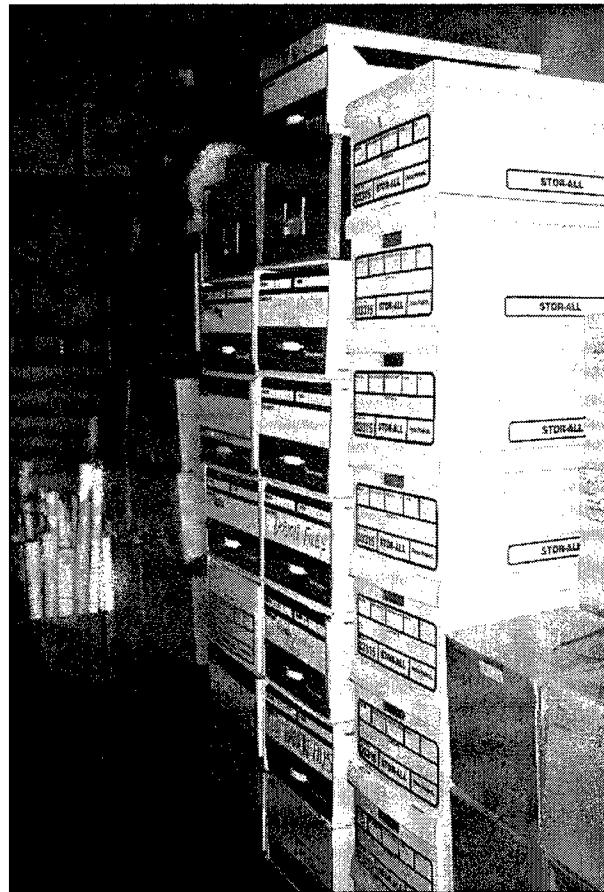
Figure 29. Retired records are stored in a rented storage space along with bulk collections.

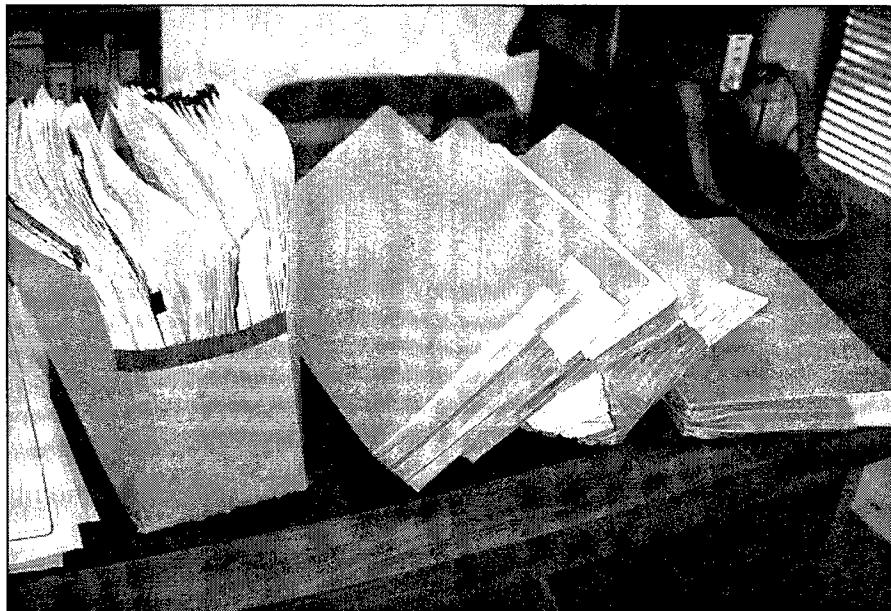
Avon Park AFR, 1994 Survey. Documentation from the current survey on Avon Park encompasses approximately 15 linear inches of material. Types of paper documentation include administrative records (5%), background records (4%), field records (53%), analysis records (10%), photographic records (23%), and oversized materials (5%). All material is housed in one of two ways—either in three-ring notebooks or in manila folders that have been placed in acidic, legal-size, accordion-type folders. Most manila folders are labeled directly in a variety of media—pencil, pen, and marker. A few labels are typewritten on nonarchival adhesive labels. All paper and folders are of acidic stock and contain contaminants such as staples and paper clips (Figure 30).

Figure 30. Avon Park AFR associated documentation held by JANUS Research.

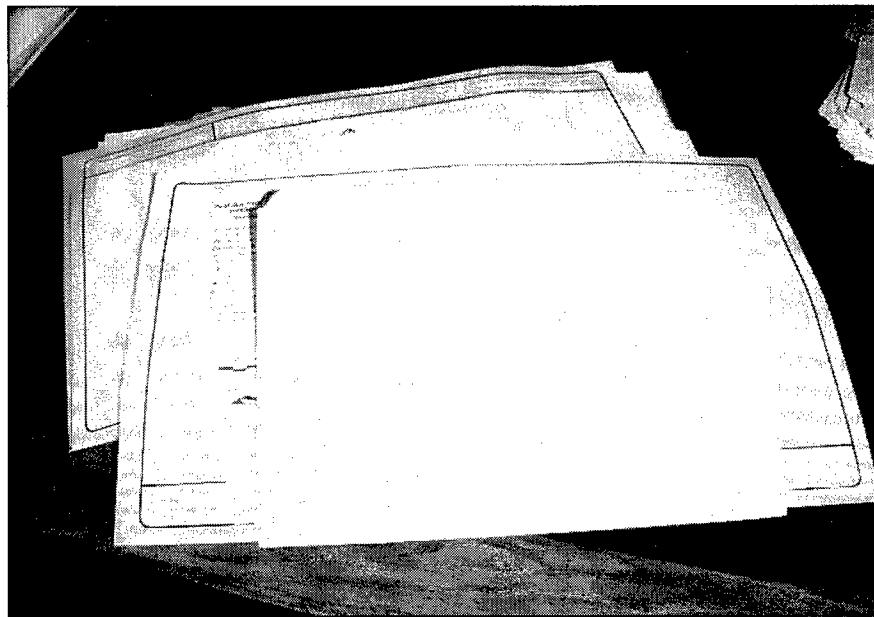
Figure 31. Camera-ready report pages are stored improperly in manila file folders.

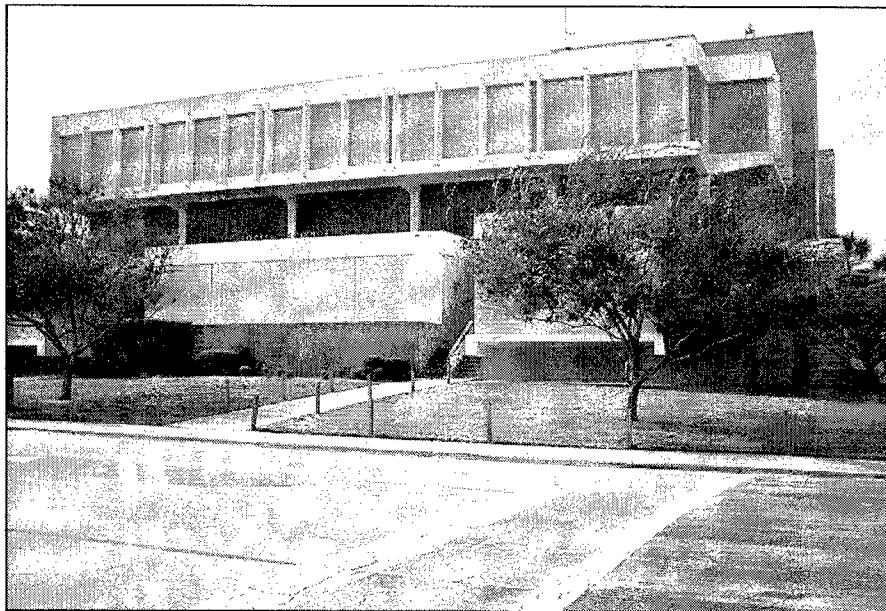
Figure 32. Social Sciences Building on the USF-Tampa campus.

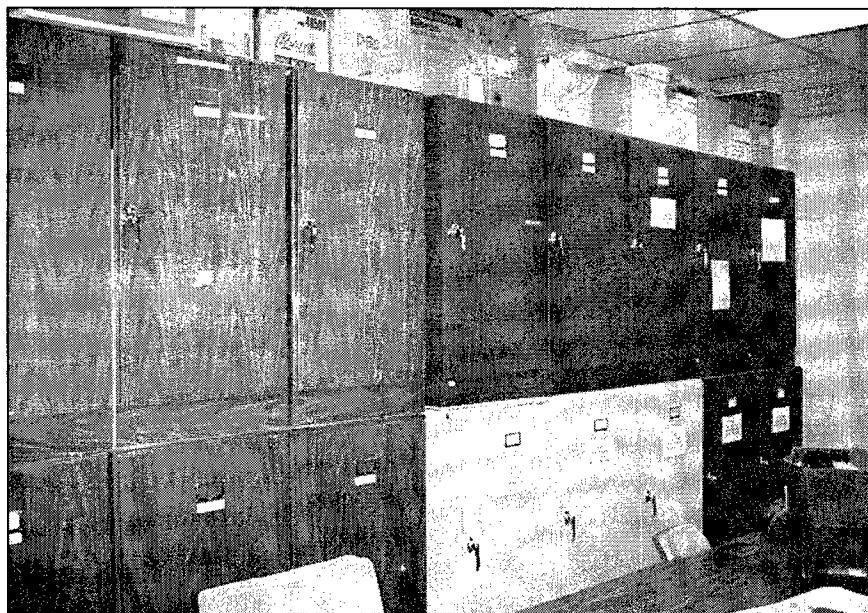
Two types of units are used to store collections. Along one wall there are several locking, wooden cabinets stacked two high (Figure 33). Along the opposite wall are homemade wooden shelves. Each shelf measures 47 x 19.5 x 15 inches (w x d x h). Seven shelves are stacked to create a rack. The wall is covered by five racks of wooden shelving units (Figure 34). The

Figure 33. Type and special collections are stored in locking wooden cabinets.

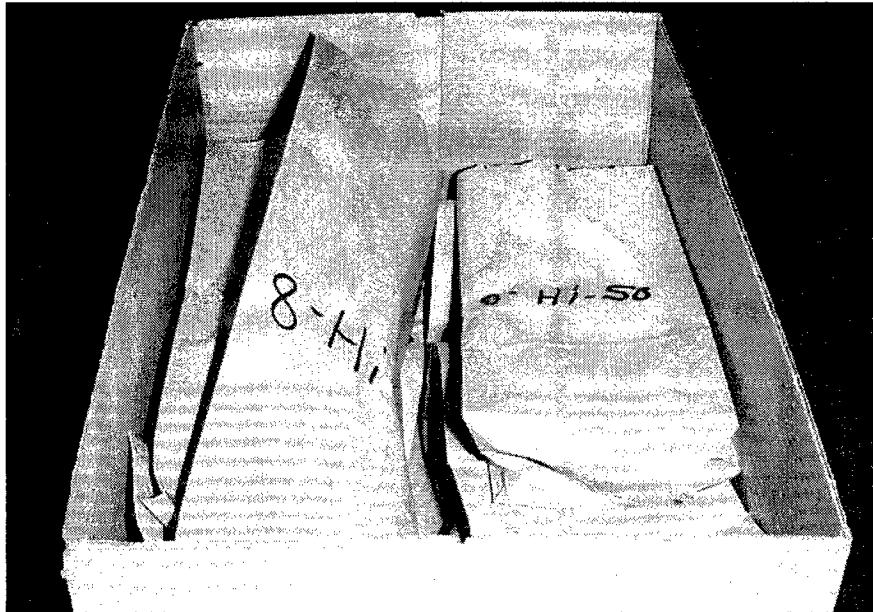
Figure 35. Acidic paper bags, labeled directly in marker, are used as secondary containers.

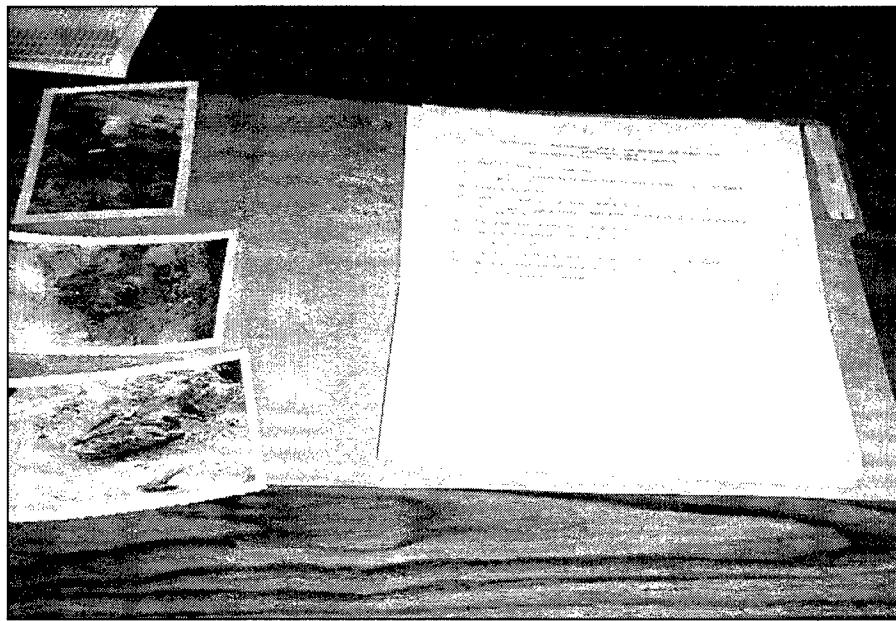
Figure 37. No special arrangements are made for photographic materials, which are stored improperly.

8. Place all photographic materials in archival-quality polypropylene sleeves, and place sleeves in acid-free, three-ring photograph binders. Photograph logs should be on acid-free paper in indelible ink.

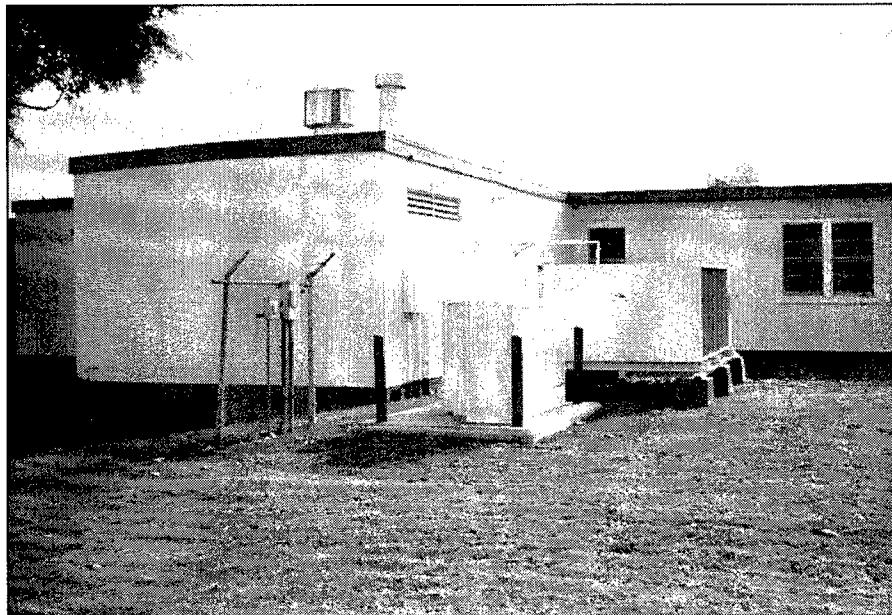
Figure 38. The boiler for Building 5088 is located in a connected, adjacent building.

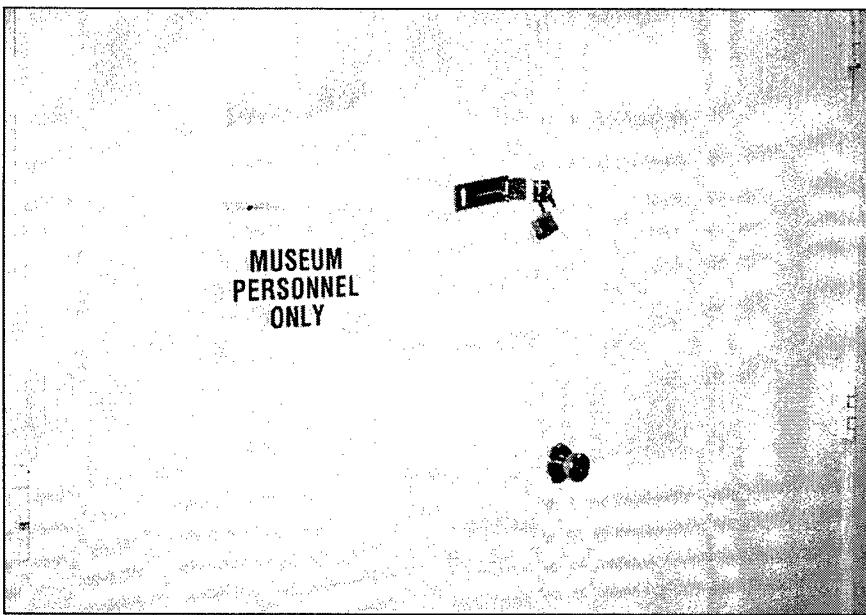
Figure 39. Hasps and padlocks are installed on all interior doors of the 8th AF Museum.

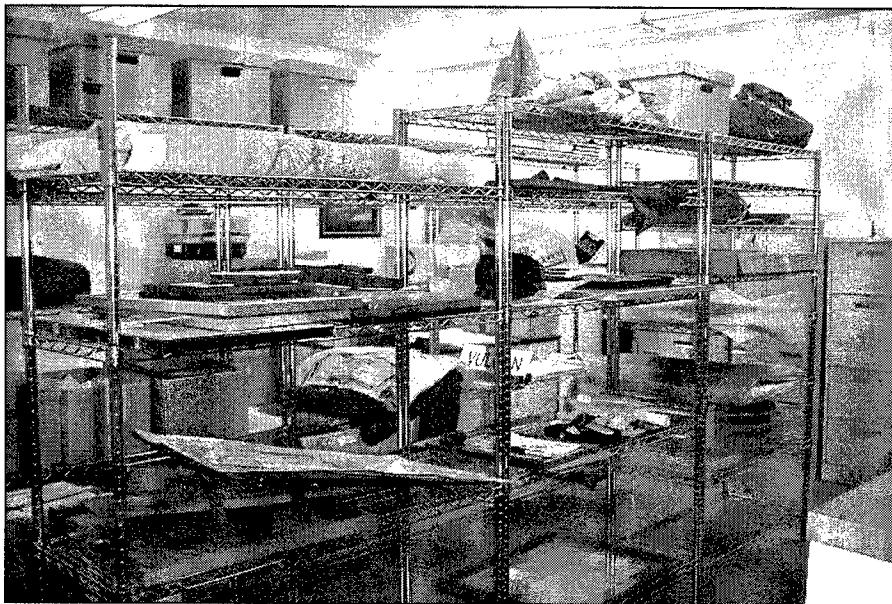
Figure 42. Collections storage area at the time of the evaluation.

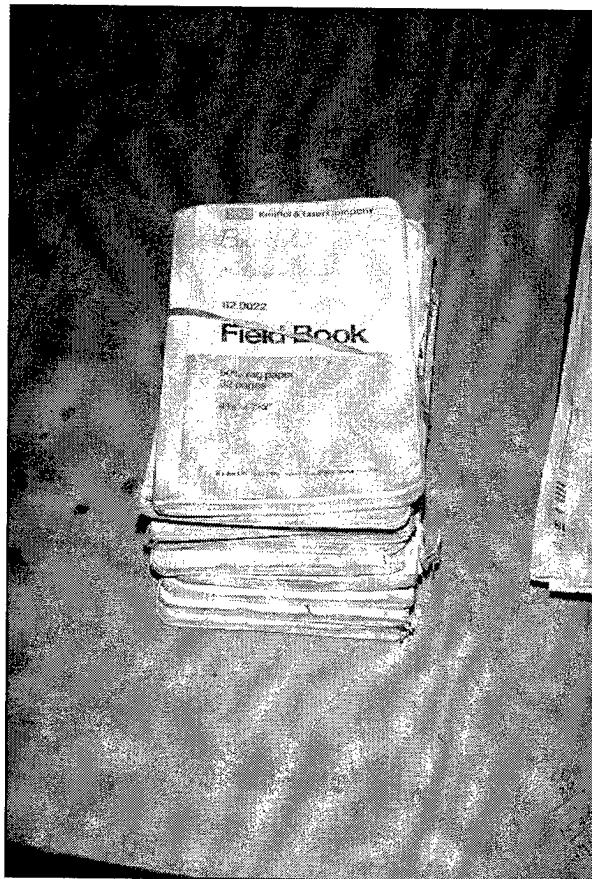
SCIAA is currently storing approximately 0.75 linear feet of associated documentation from Barksdale AFB. Eighty percent of the associated documentation consists of field notebooks and catalog and inventory records. These materials were stored in the processing laboratory with the artifacts. The field books have been secured together with a rubber band, but no other storage arrangements have been made. Each field book is labeled directly in either pencil or pen on the front cover with the name of the investigator and the project name (Figure 45). Inventories and catalogs were temporarily housed in acidic accordion-type folders in the processing laboratory. The remaining 20 percent of associated documentation comprise administrative records including correspondence, a copy of the proposal and scope of work, and miscellaneous notes concerning the administration of the project. At the time of the evaluation, these

Figure 45. Field books from the archaeological work at Barksdale AFB are stored temporarily in the processing laboratory.

7. Remove all contaminants (e.g., staples, paper clips, and rubber bands) from the documents.
8. Duplicate all paper records onto acid-free paper, and place in acid-free folders labeled in indelible ink. Place all folders in acid-free cardboard boxes, and apply adhesive, polyethylene plastic label holders, with acid-free inserts, to the boxes.

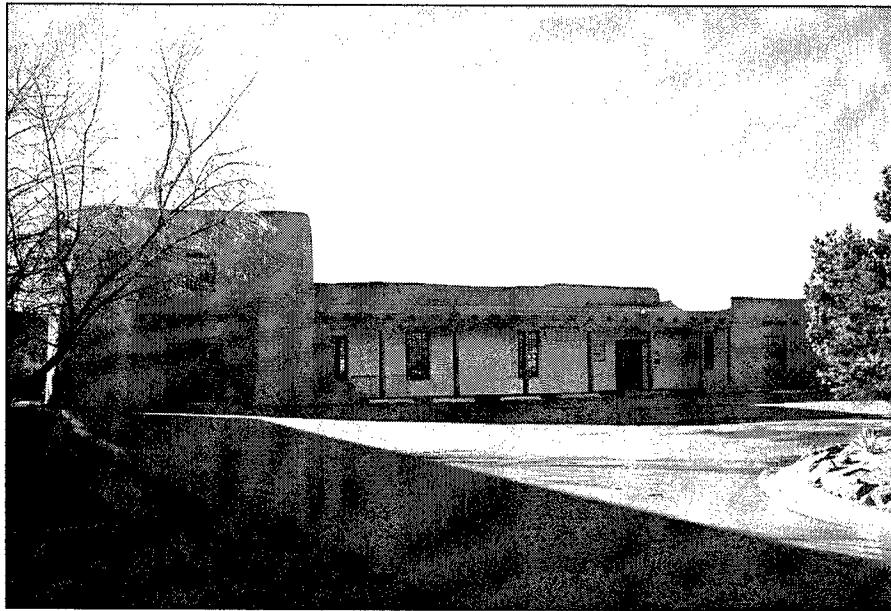
Figure 47. Exterior of the Laboratory of Anthropology building, which houses both NMARMS and ARC.

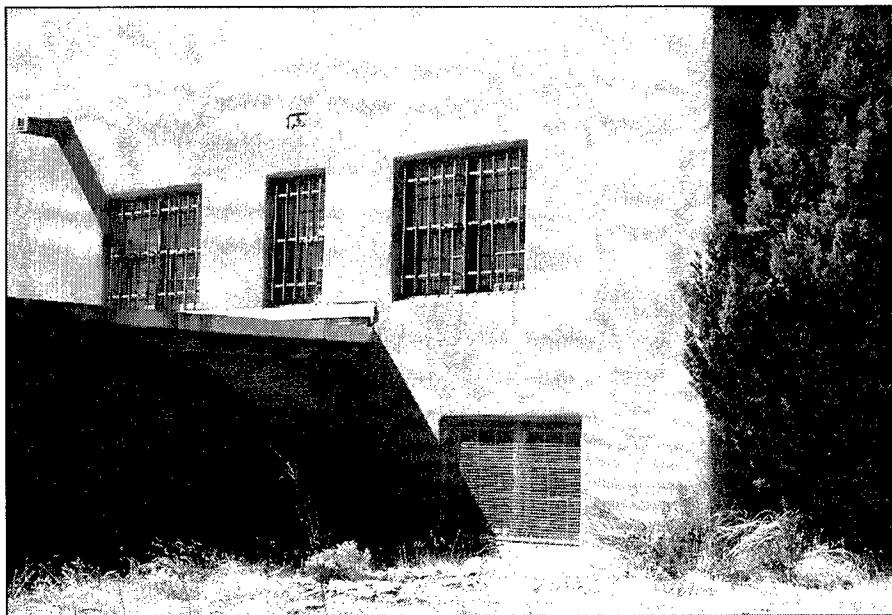
Figure 48. All windows in the NMARMS areas have steel bars on the exterior and slide locks on the interior.

NMARMS meets most of the federal requirements for safeguarding archaeological collections and associated documentation. The building is protected with intrusion alarms, motion detectors, controlled access, and locks, which are installed on all doors and windows. Although all windows are considered accessible from the exterior, each has been secured with bars on the exterior and window locks on the interior (Figure 48). Motion detectors are located throughout the facility. The front entrance to the building is secured with a double-cylinder, dead-bolt lock and a key-pad security code. The intrusion alarm and motion detectors are all wired directly to a private security company. The evaluation team noted no evidence of unauthorized entry, and staff indicated that no past episodes of this type have occurred.

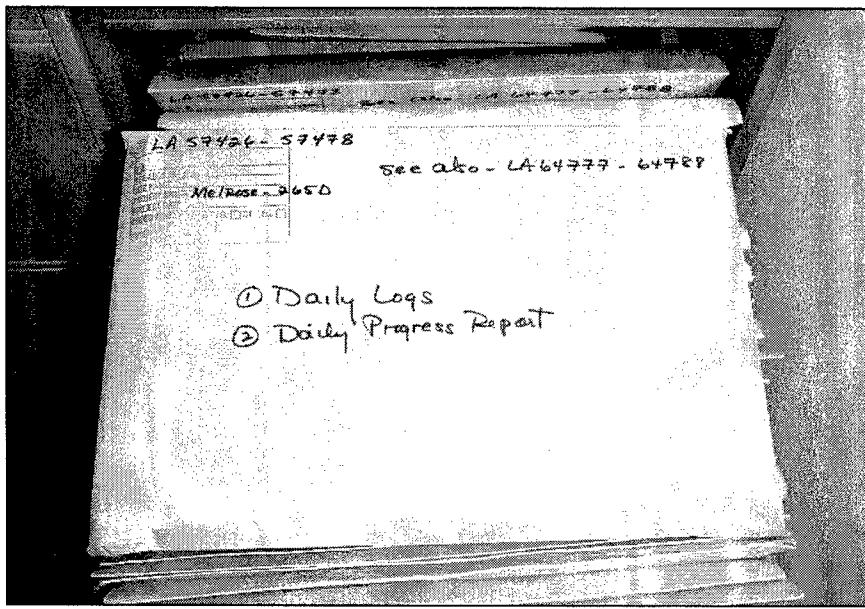
Figure 49. Melrose AFR documentation is housed in acidic manila envelopes that are labeled directly in marker and with a customized stamp.

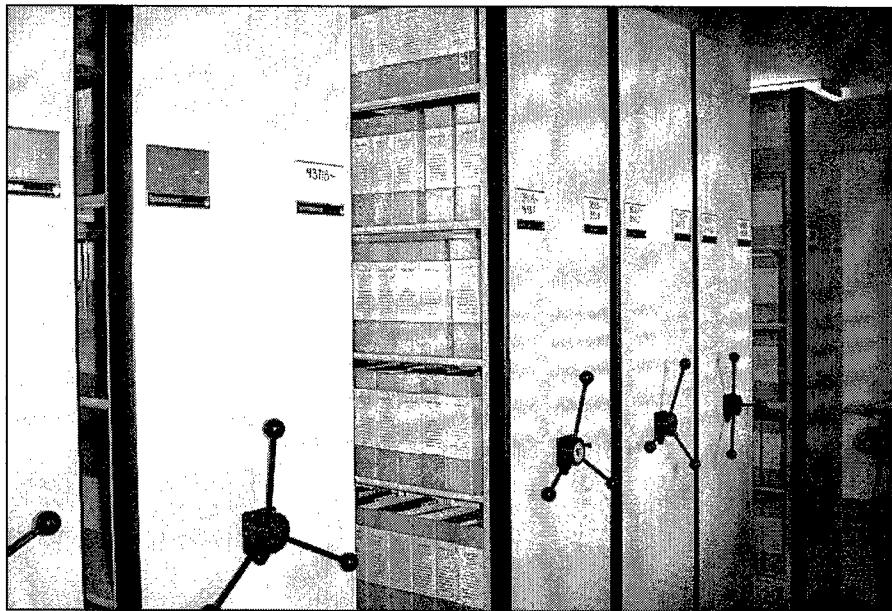
All reports are stored in a room separate from the associated documentation. None of the reports have been copied on acid-free paper, nor have the nonarchival bindings been removed. Reports are systematically numbered upon receipt and are added to the NMCRIS database for information retrieval. All reports are housed in acidic cardboard magazine holders, which have been labeled directly in pencil. Labels are consistent throughout the collection and are simply the report numbers contained in each individual storage unit. All of these magazine holders have been placed on compact shelving installed specifically for the storage of these reports (Figure 50). These shelving units have reached approximately 60 percent capacity.

Figure 50. Reports are stored on compact shelving units at NMARMS.
